Manhole Inspection Summary

Manhole # S35EE1016MH

Insp Date: **1/30/07 10:06 AM**

Location Address: **3801 FENCHURCH RD** Cross Street: **CHANCERY SQ**

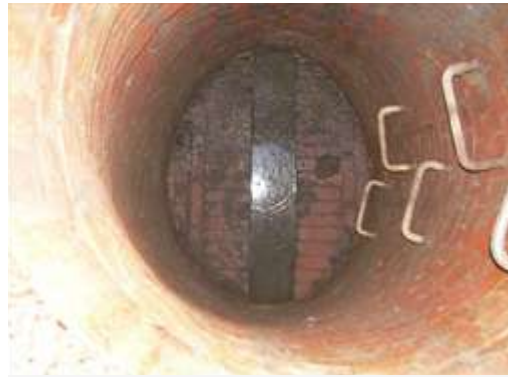
Top View

Bench ☒ Exists Material: **Brick** ☐ Parged ☒ **Debris** (not Condition related)
Condition: ☒ Sound ☐ Cracked ☐ Root Intrusion ☐ Deteriorated ☐ Leaks ☐ Debris

Surcharge ☒ **Evidence Of Surcharge** Depth: **1** (ft.) ☐ Active Surcharge Present

Evidence of surcharge - Bench debris.

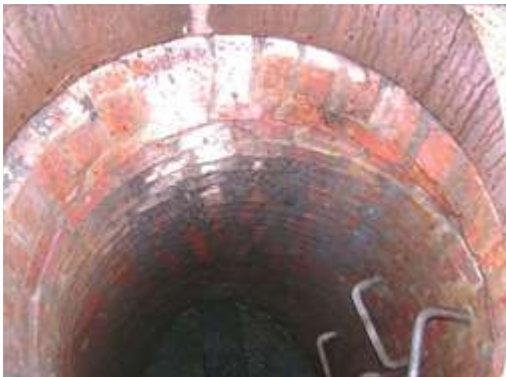
Defect

Chimney / Frame Adjustment ☒ Exists Material: **Brick** ☐ Parged Height: **5** (in.)
Condition: ☒ Sound ☐ Cracked ☐ Root Intrusion ☐ Loose Brick ☐ Deteriorated
Infiltration: ☐ None ☒ **Joint** ☐ Cracks ☐ Mortar ☐ Roots ☒ **Wall**

Corbel Material: **Brick** ☐ Parged Type: **Concentric/Eccentric**
Condition: ☒ Sound ☐ Cracked ☐ Root Intrusion ☐ Loose Brick ☐ Deteriorated
Infiltration: ☐ None ☐ Joint ☐ Cracks ☐ Mortar ☐ Roots ☒ **Wall**

Barrel Material: **Brick** ☐ Parged
Shape: **Circular** Diameter: **42** (in.) Length: (in.)
Condition: ☒ Sound ☐ Cracked ☐ Root Intrusion ☐ Loose Brick ☐ Deteriorated
Infiltration: ☐ None ☐ Joint ☐ Cracks ☐ Mortar ☐ Roots ☒ **Wall**

Adjustment, Corbel and Barrel infiltration.

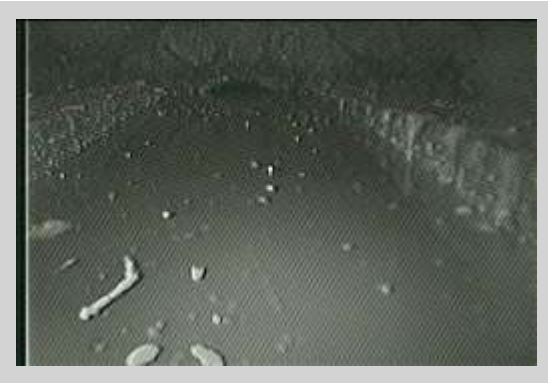
8 in. Circular Gravity Sewer Pipe Out @ 12 O'Clock

STANDING WATER

Infiltration: **Evidence** Pipe Seal Cond: **Unknown**

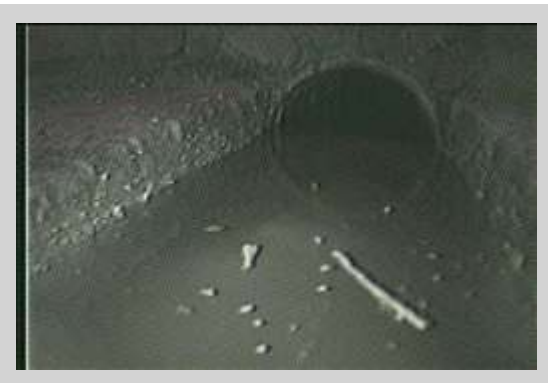
8 in. Circular Gravity Sewer Pipe In @ 6 O'Clock

Infiltration: **None** Pipe Seal Cond: **Cracked**
